# UNDERCOVER

### Swagelining® upgrades pumping main on Rugby's new Western Relief Road

## Cambrian Line UTX installed by guided auger boring

## MAJOR CULVERT ON THE WEST COAST MAIN LINE RELINED WITH ECOCI PP AT GRAYRIGG, CUMBRIA

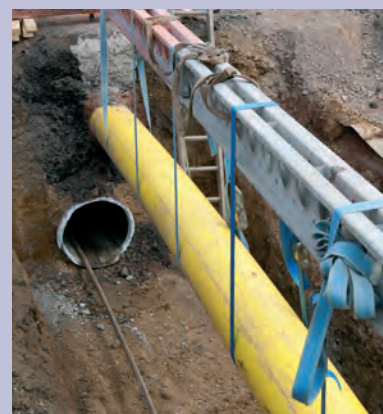
One of the access pits, showing the proximity of other services to the pumping main.

Open cut had been ruled out because of the proximity of other services including gas and electricity mains, fibre optic communications cables and a foul gravity sewer.

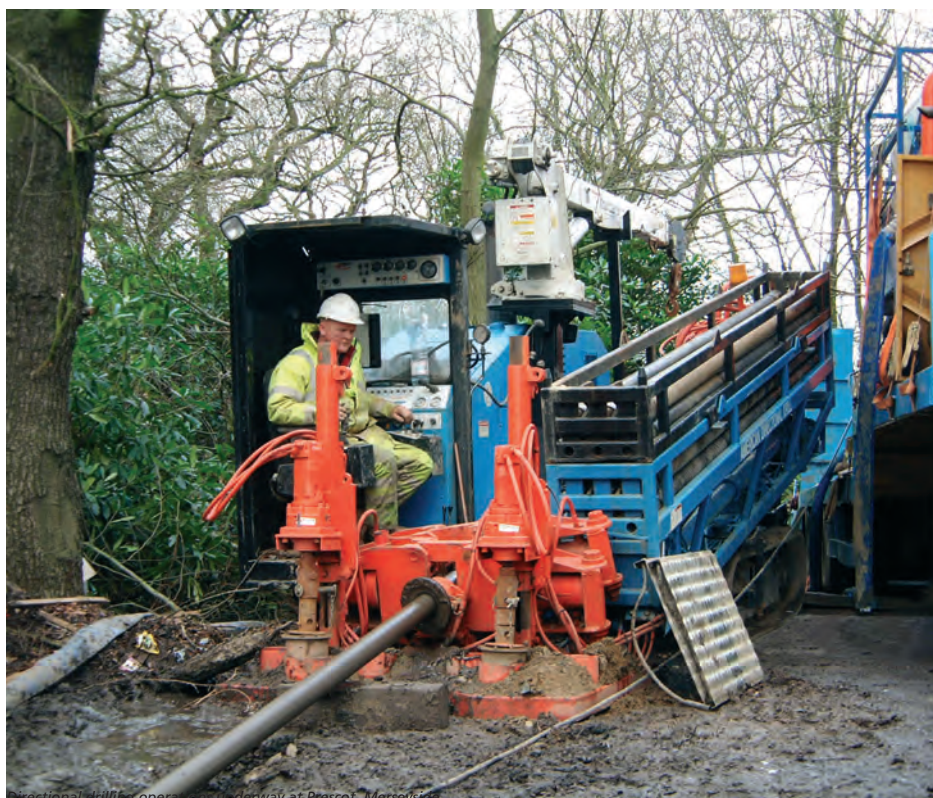
Directional drilling operations underway at Prescott, Merseyside

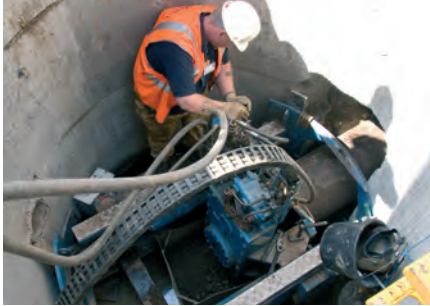
Guided auger boring works are carried out with a BM400 rig

Back in May, our auger boring team took a BM400 rig to Commins Bach, near Machynlleth, Powys on the Cambrian Railway to install an under track crossing for Carillion Rail. The UTX work was undertaken from two, two metre diameter launch and reception pits which were installed in routine line possessions. The augering work was carried out in a three day window to install a 225mm ID lost steel pipe in a 12 metre shot. The works were carried out without any

Guided auger boring was chosen for the UTX installation because of its supreme accuracy, the fact that rail operations can continue unaffected and its ability to achieve settlement of +/- 3mm at track level, which negates long term settlement.

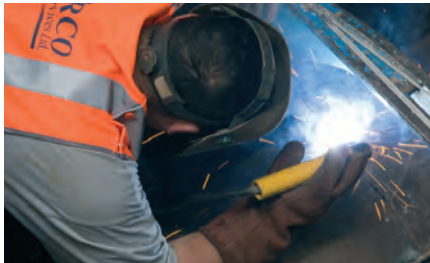
Welding sections of lost steel casing during augering

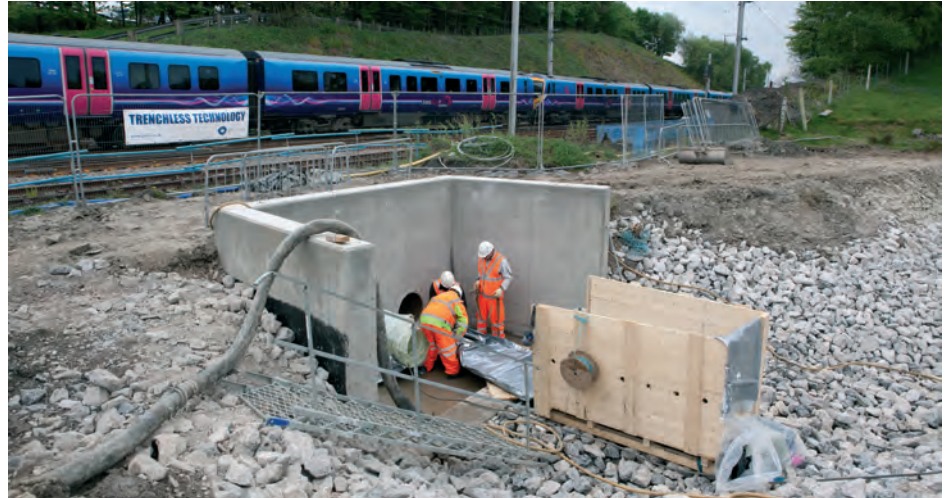
A culvert carrying a beck under the west coast main line at Grayrigg in Cumbria had been replaced with three no. 600mm ID steel pipes. To minimise the effects of erosion from stone bearing storm flows, we lined the pipes with EcoCIPP UV cured in place liners. EcoCIPP was chosen for its excellent wear resistant characteristics, ease of installation and excellent environmental properties. EcoCIPP's UV curing characteristics made it the ideal solution due to restricted access on the east side of the railway track.

All curing operations could be operated from the launch site on the west side of the track.

The works were carried out whilst train operations carried on unaffected. The work was carried out in a five day window using the access pits for the pipe installation. Installation equipment was positioned in the reception pit during a routine line possession.

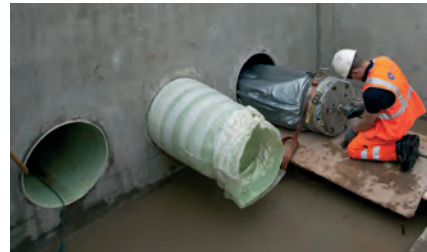
EcoCIPP liners in place in each pipe. One finished, one awaiting trimming and the third being prepared for inflation

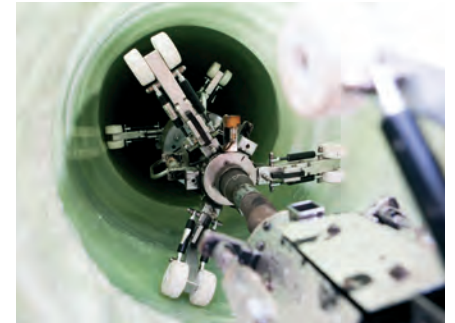
The UV light train in the newly cured second pipe.

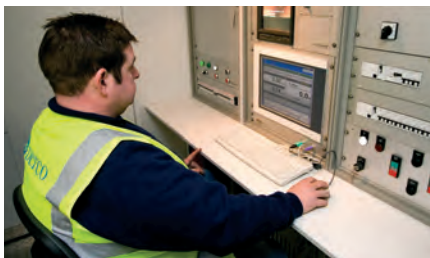
Monitoring progress of the EcoCIPP UV curing process

Following analysis of the test reports and CCTV footage it was decided that 20 sections of pipe totalling 400 metres needed to be relined. The EcoCIPP UV cured in place liner was chosen as it gives additional structural strength to the pipes as well as improving flow. The affected pipes ranged in diameter from 225mm ID to 900mm ID.

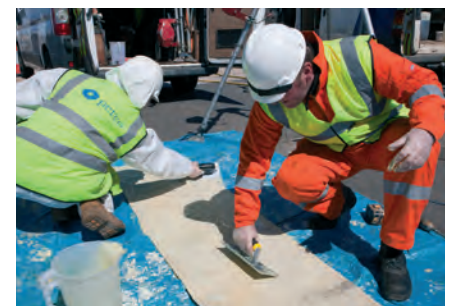
Resin is applied to a section of EPROS patch liner

An additional six sections of pipe only needed localised patch repair. The EPROS patch liner system was chosen for this task.

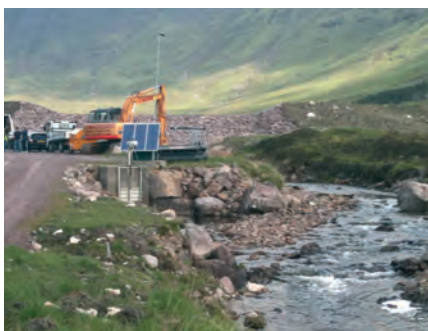
Looking up Russel Burn towards the new dam. The raised penstock of the outlet pipe is to the right of the track.

Aecom constructed a new dam wall to increase capacity of the reservoir by around 30%. The existing reservoir outlet pipes were still usable but there were concerns about the integrity of the lower outlet pipe. The lower pipe, at a depth of around 4.5 metres below ground was found to be leaking due to failure of some of the pipe joints.

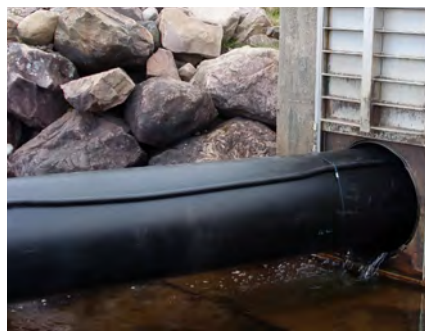
The new pipe is pushed into the host pipe. One of the three grouting tubes can be seen on the top of the new pipe.

Following talks between Aecom and our engineers, 'push' sliplining, rather than the conventional 'pull' sliplining, was identified as the most practical solution.

630mm OD SDR 17.5 PE pipe was transported to site in sections and butt fused into a 126 metre long, continuous pipe. Spiders were used to position grouting tubes at 30, 60 and 90 metres along the pipe to allow grout to be pumped into the annulus between the host pipe and the new pipe after installation.

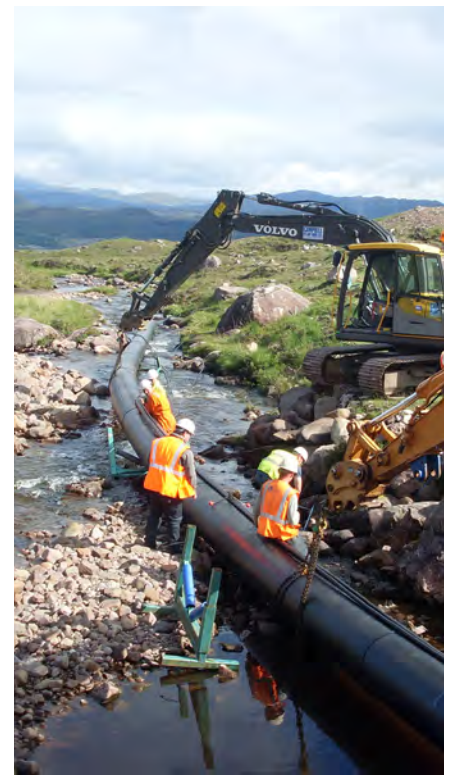
The butt-fused pipe is prepared for pushing

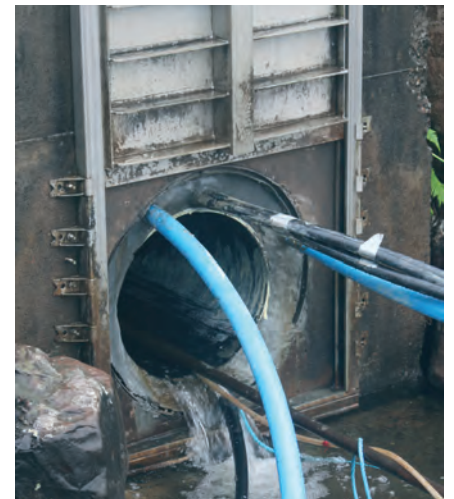
The newly installed pipe showing the grouting tubes, pushing rod and air line for the patch liner

After being pushed into the host pipe, the EPROS patch liner was pushed into position over the stepped joint and inflated against both pipes. This was a complex procedure due to the length of the pipe, the flows of very cold mountain water through the pipe and the fact that the patch liner is an ambient cure product, designed to cure at low temperatures. The patch liner was successfully positioned and then the annulus was grouted up using the previously installed grouting tubes.

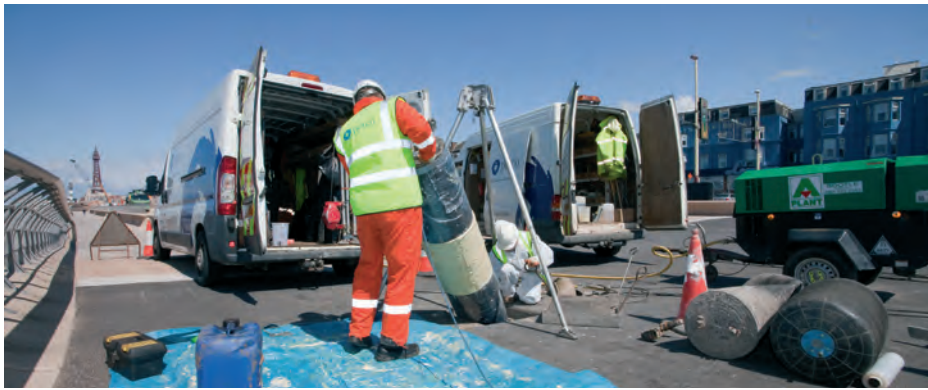
The patch liner and packer are lowered into the manhole

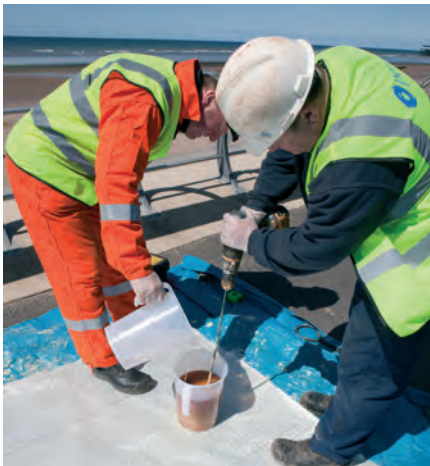
Preparing the epoxy resin for pouring on to the EPROS mat

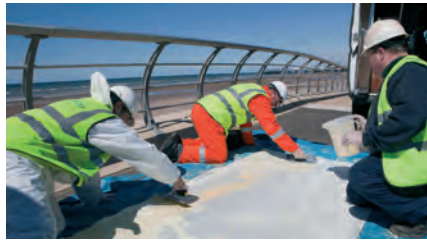
Resin is applied to a section of EPROS patch liner

Following CCTV inspection, EPROS patch lining was recommended and adopted as the preferred working method. Whilst excavation and external

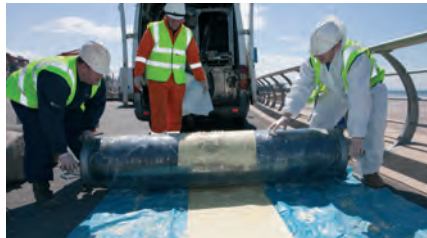
The patch liner is wrapped around an inflatable packer
